Manhole Inspection Summary

Manhole # S02WW1020MH

Insp Date: **8/15/06 12:00 AM**

Location Address: **3900 Fordleight Rd** Cross Street: **Reisterstown Rd**

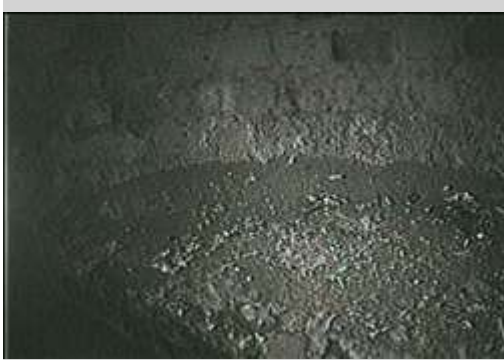
Defect

Condition: ☐ Sound ☐ Cracked ☐ Root Intrusion ☐ Deteriorated ☐ Leaks ☒ **Debris**

debris on bench

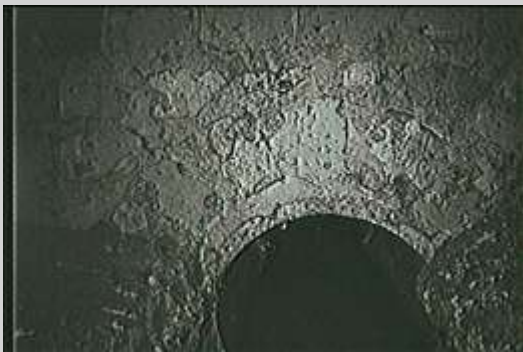
10 in. Circular Gravity Sewer Pipe Out @ 12 O'Clock

Deposits: ☐ None ☐ Mud ☐ Sludge ☒ **Debris** ☐ Grease

Silt Depth: **0.5** (in.) Deposits Extent: **Light**

Infiltration: **None** Pipe Seal Cond: **Sound**

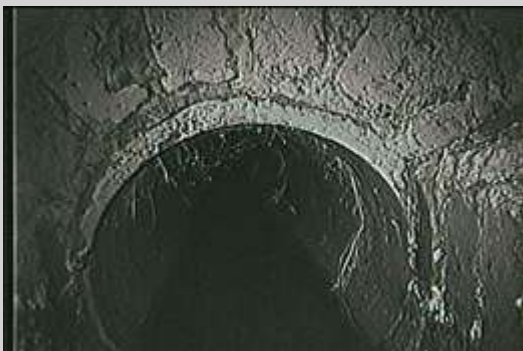
10 in. Circular Gravity Sewer Pipe In @ 6 O'Clock

Deposits: ☐ None ☐ Mud ☐ Sludge ☒ **Debris** ☐ Grease

Silt Depth: **0.5** (in.) Deposits Extent: **Light**

Infiltration: **None** Pipe Seal Cond: **Sound**
